Fig. 1, Villa Mirabello, main entrance.

This paper hosts first results of investigation, crossing historic documentation and non destructive diagnostic.

Focus of diagnostics is mapping texture of structures beneath plaster; plus, for damage assessment, IRT helped to evaluate total extension of delaminated coating. Results of IRT were verified by endoscopy and stratigraphic sampling.

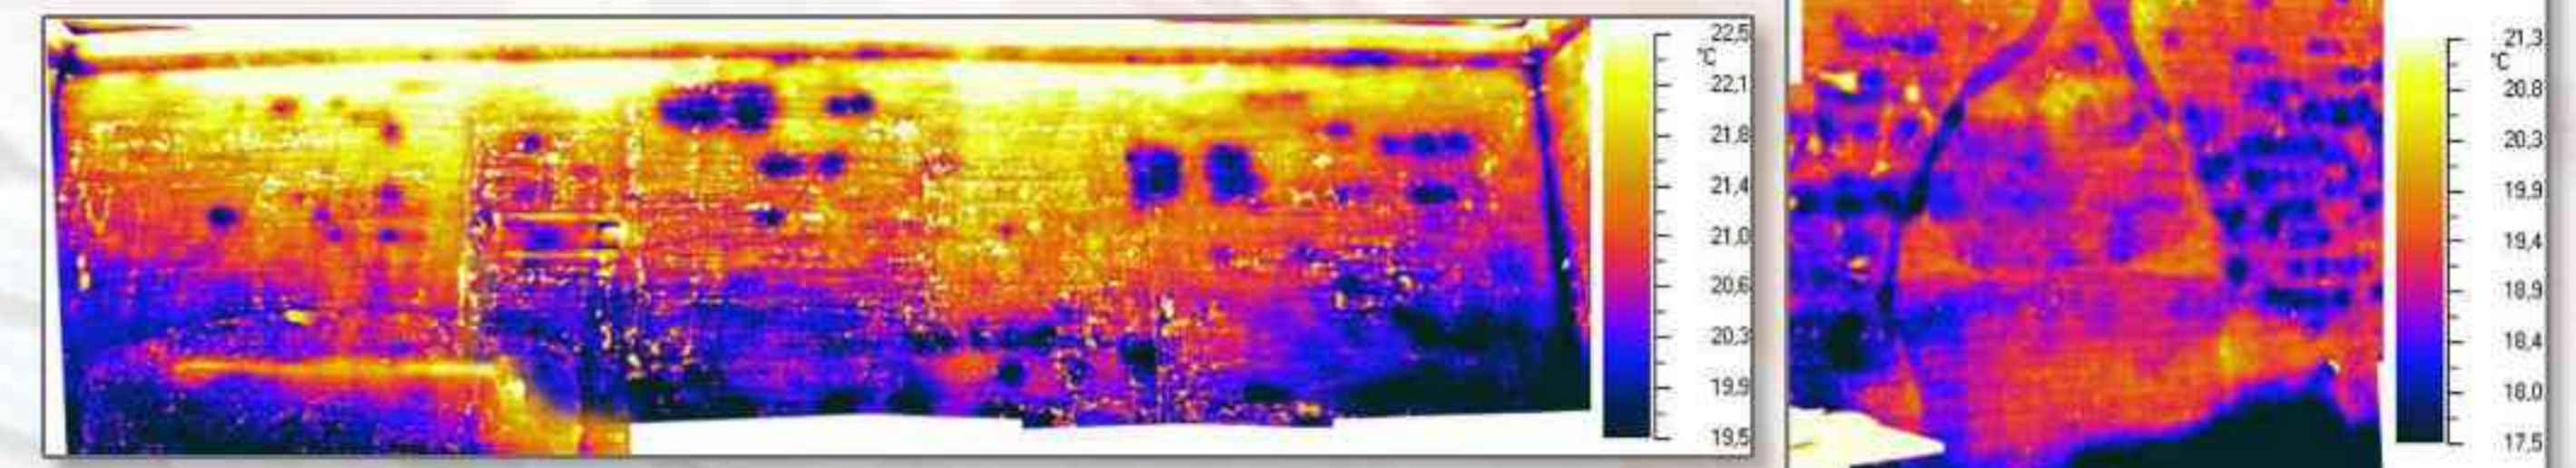
Fig. 3, IR Thermograms composite of wall "B", room # 3; it shows a regular bricks pattern, in which stone quoins are included (blue spots). "Ceppo" quoins have different size and shapes.

By now, historic documentation explains consolidating technique: builders inserted "ceppo" stone quoins in brick masonry. These stones are now recognizable at IR, because of different thermal characteristics of stone and brick [fig. 3, 8]

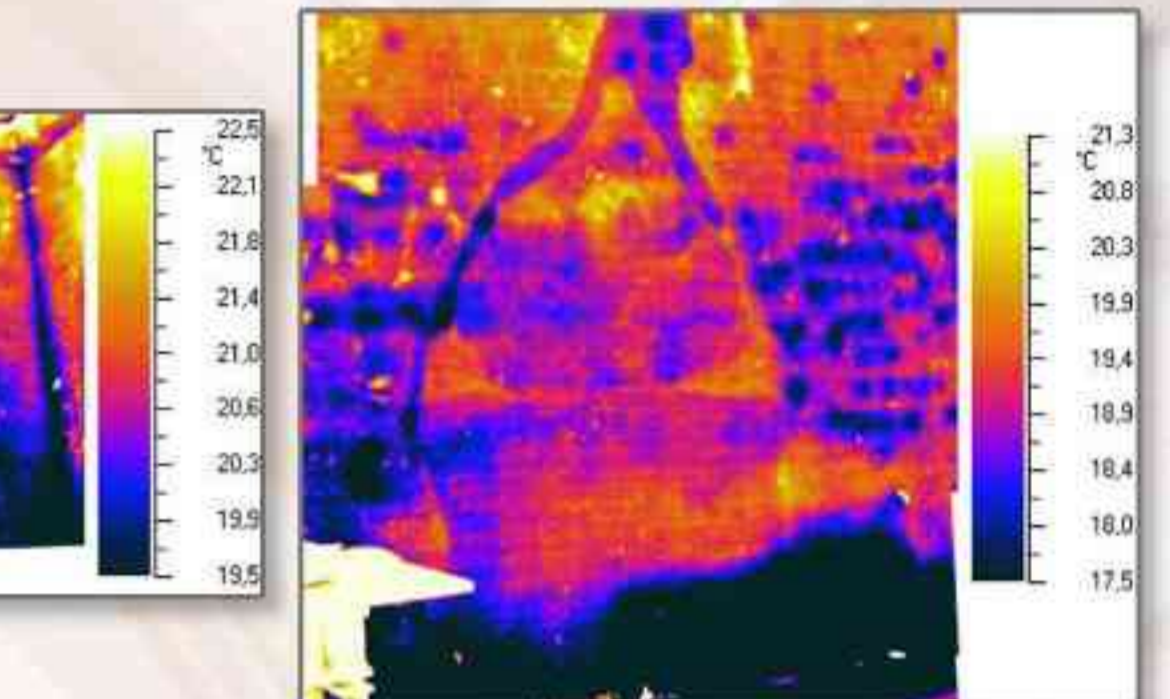
Fig. 4, IR Thermograms composite of wall "A", room # 2.1; it shows a infilled opening and plaster patches, arch shaped. Opening infilling consists of bricks, surrounding masonry has a bricks&pebbles texture.

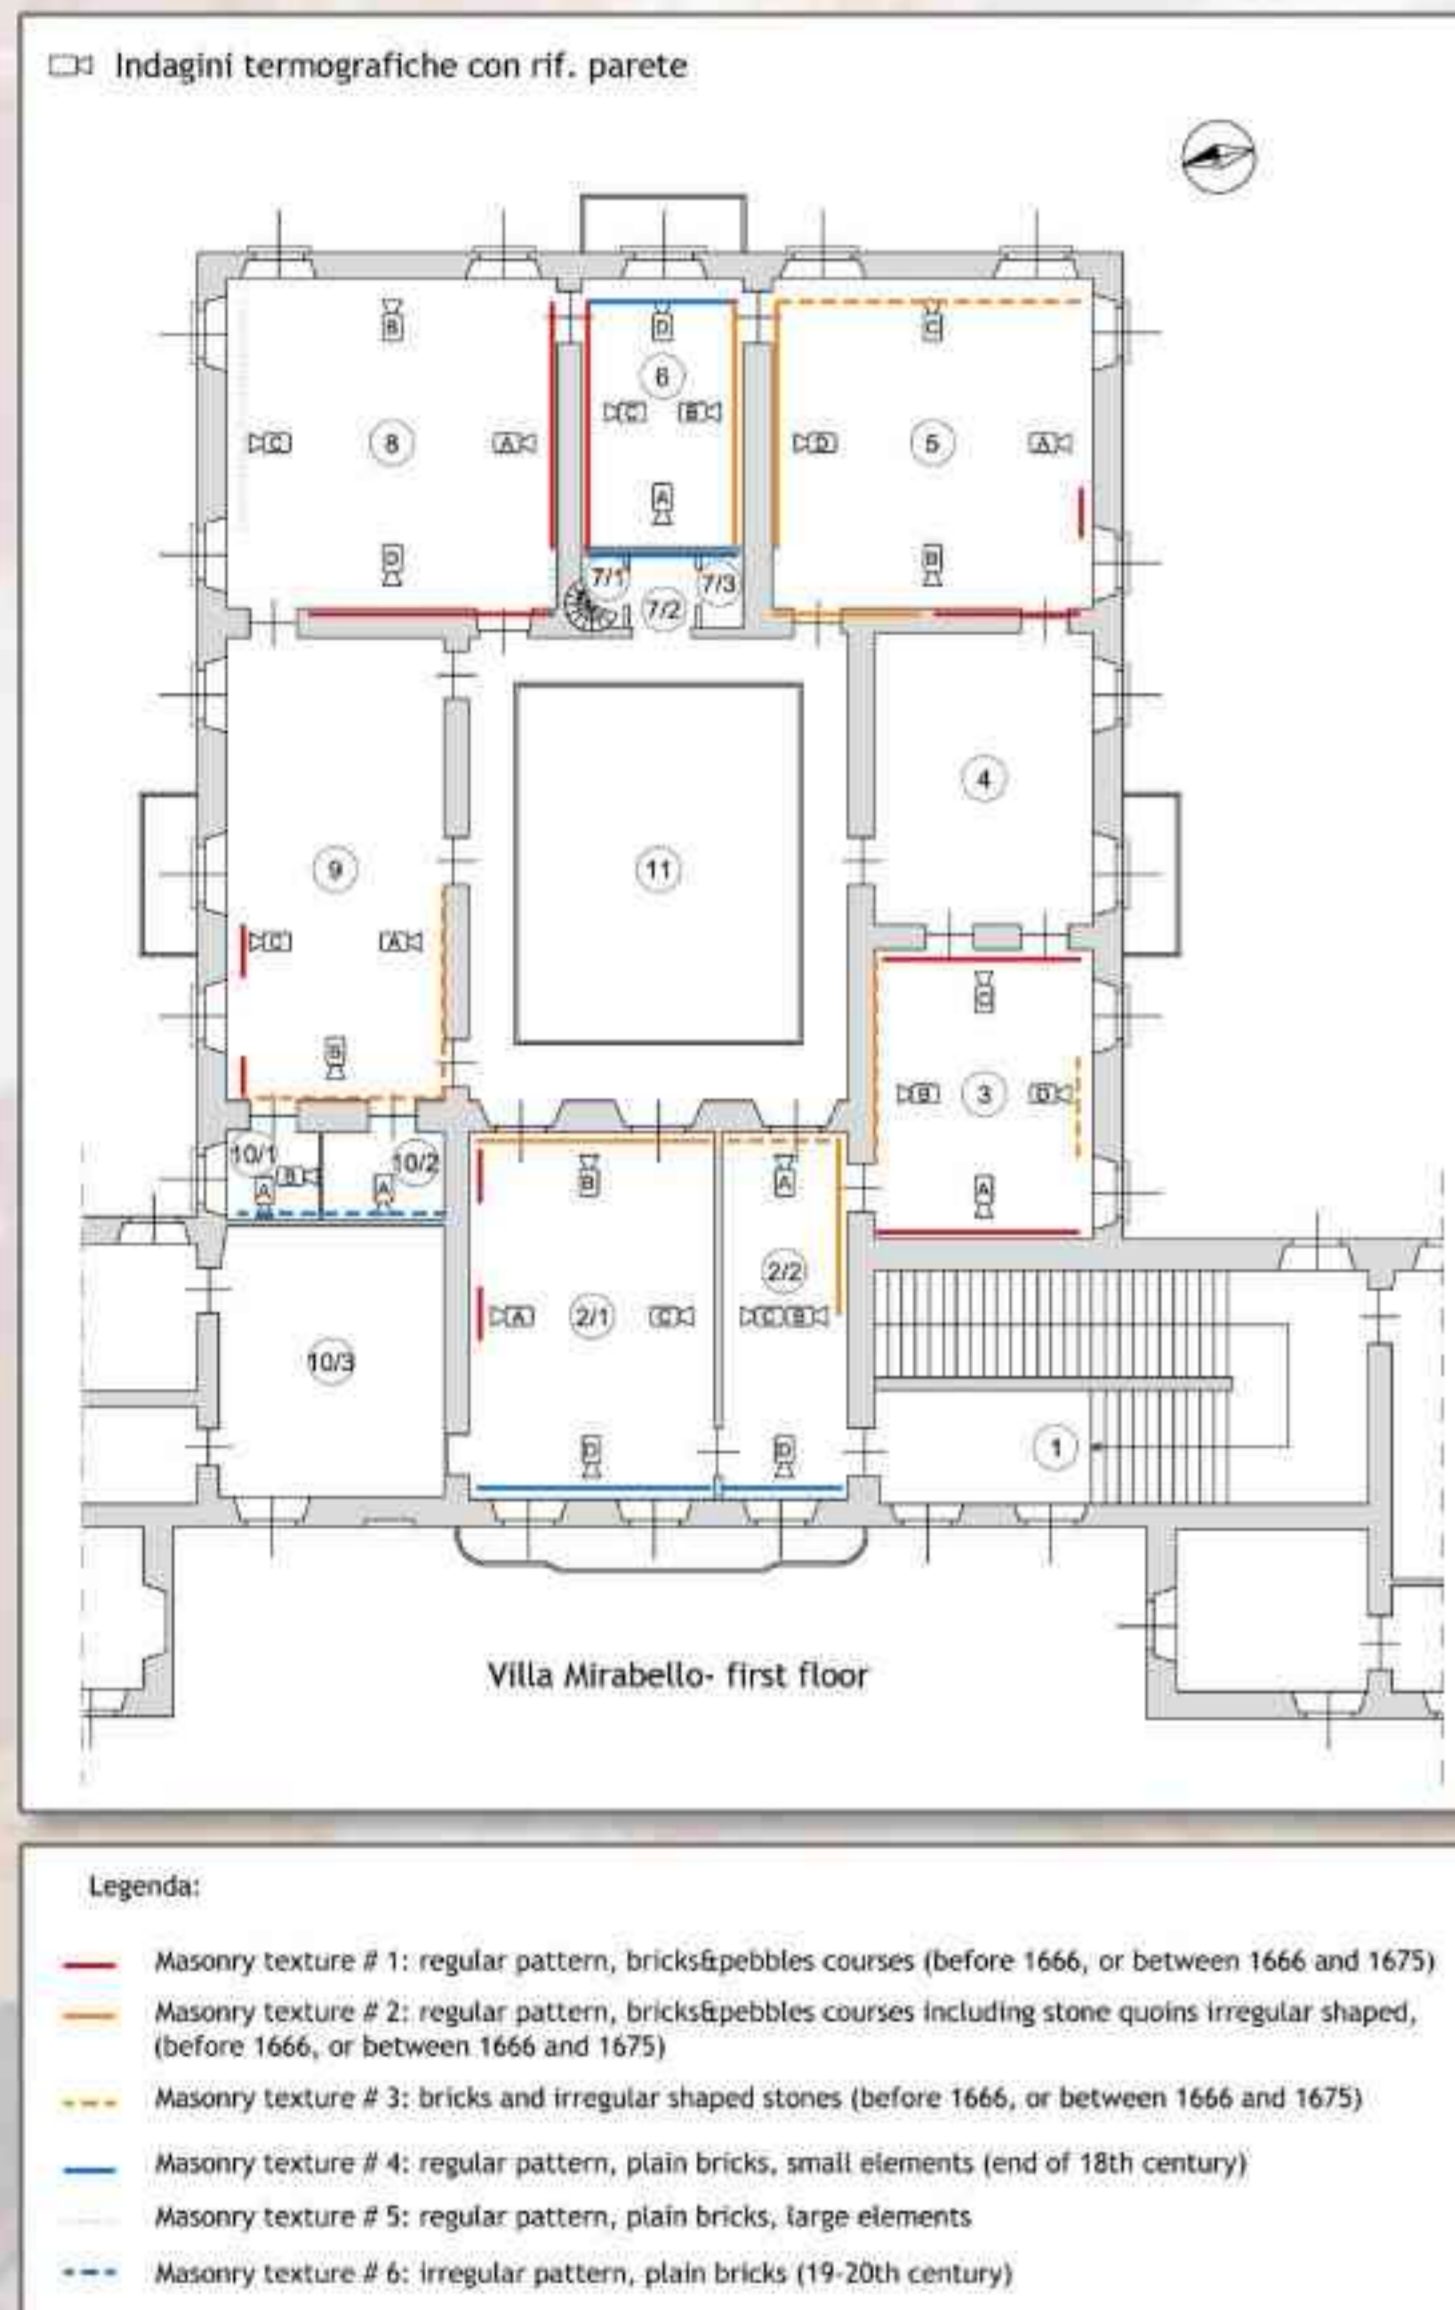
Fig. 2, plant of first floor showing results of integration between historic research and IRT

IRT showed four texture typologies: their location within the building proved historical hypothesis. A unique texture, timber framed, was found between rooms 2.1 and 2.2. It is totally different from the others, and it was used for subdividing the existing large room, facing facade, at first floor. [fig. 2]

Especially, investigation at Villa Mirabello allowed to map four kinds of recurrent texture: bricks and mortar, pebbles and bricks embedded in alternate string courses, bricks and few stone quoins (irregularly shaped), timber frame wall. The following image shows location of resulting texture within Villa's plant.

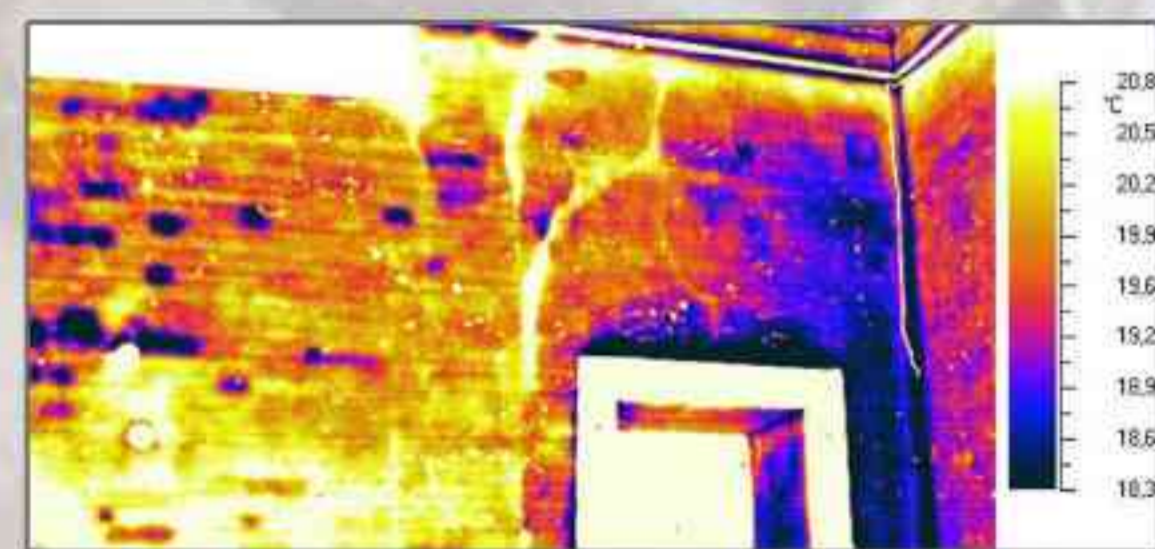
Fig. 5, IR Thermograms composite of wall "B", room # 5

For example, in fig. 5, note that different patterns are side by side, without any joint or cut in masonry, IRT even shows that brick courses are perfectly aligned with pebbles ones.

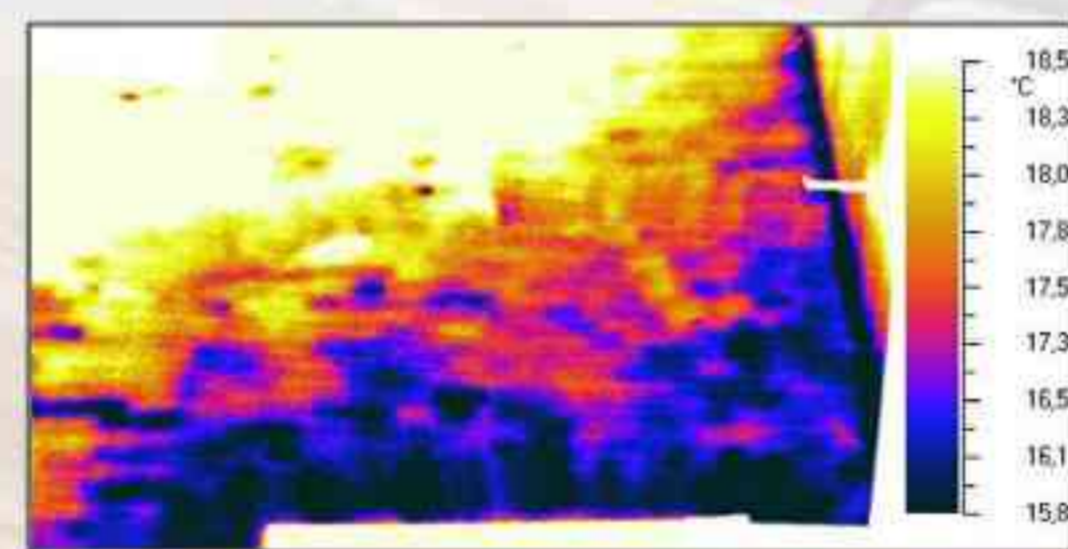
Moreover, IRT showed a hidden large arch in "B" wall over the present entrance door [fig. 6] (the investigated "B" wall is the rear of staircase). Presence of arch means that entrance door was wider than the present one and that stairs changed during their first building, probably because of weakness of roof supporting structures (from a report in historic documentation).

Fig. 6, IR Thermograms composite of wall "B", room # 2.2; thermography allows to detect a large arch over the present entrance door.

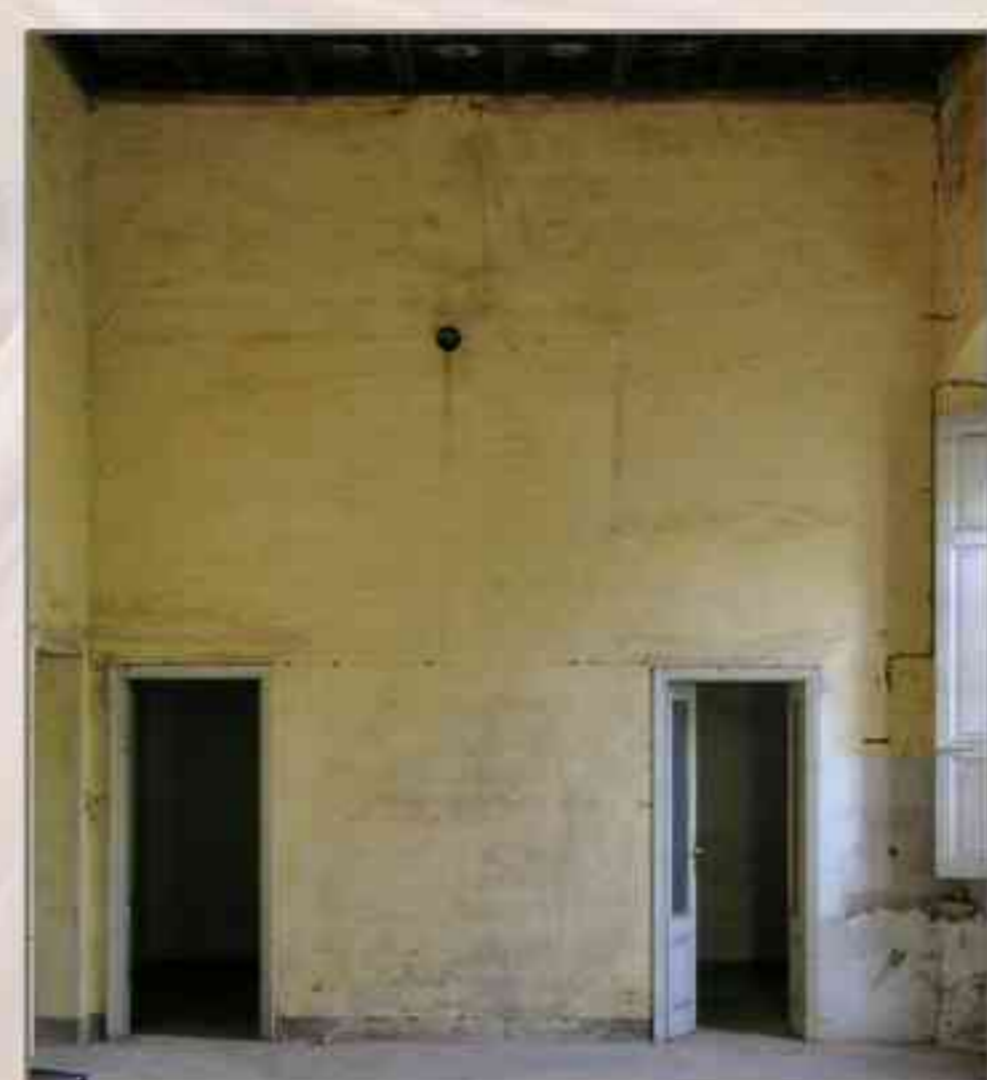
Fig. 7, visual state of wall "B", room n 9

3) Discovery of another arch, in wall "B", room 9, let us hypothesize that it was an entrance of Cardinal Durini aisle, which connected this part of the apartment of a gallery on the chapel' side, close to the altar. Only archive documents report about this aisle, nowadays none traces was found, apart from IRT detection of the arch.

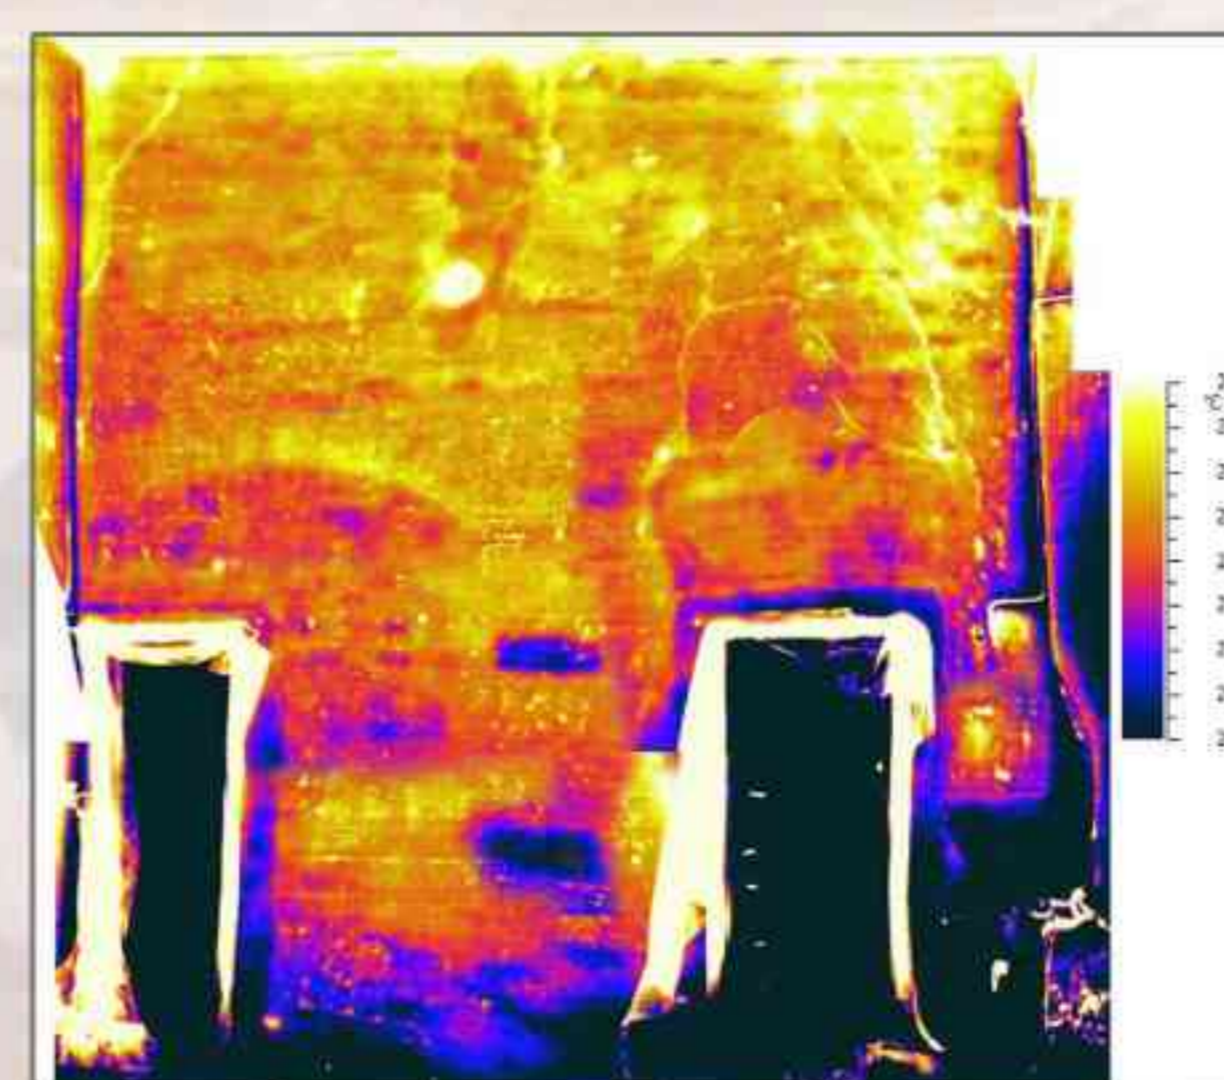
Moreover, observing arch shape and dimension, authors noticed that arch's left pillar is lacking, and wall "A" leans on "B", therefore "B" belongs to the first building, and it was used by Quadrio for the new aisle.

Fig. 8, IR Thermograms composite of wall "B", room # 9; thermovision allows to detect a large arch over the left door.

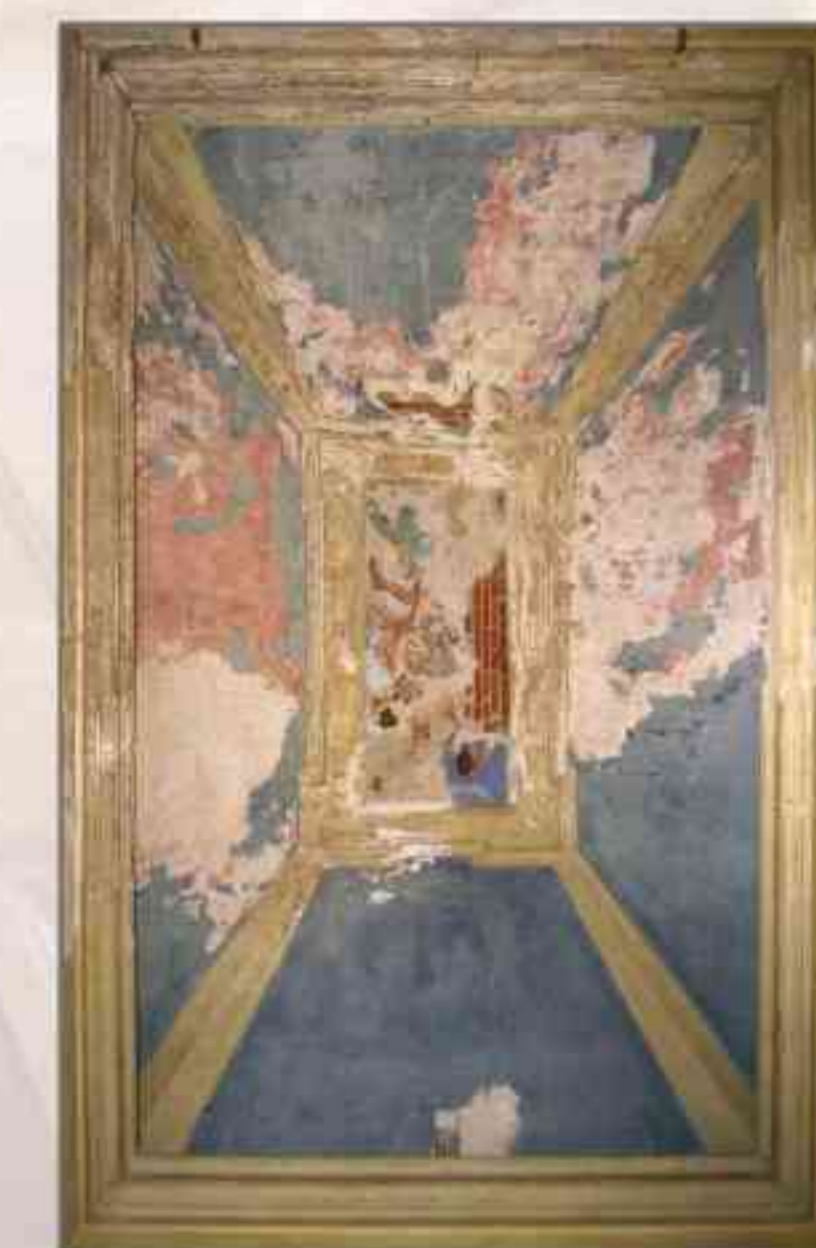
Fig. 9, visual state of vault in room # 6; damage of surface (stains, lack of color, lack of plaster, etc) masks delamination.

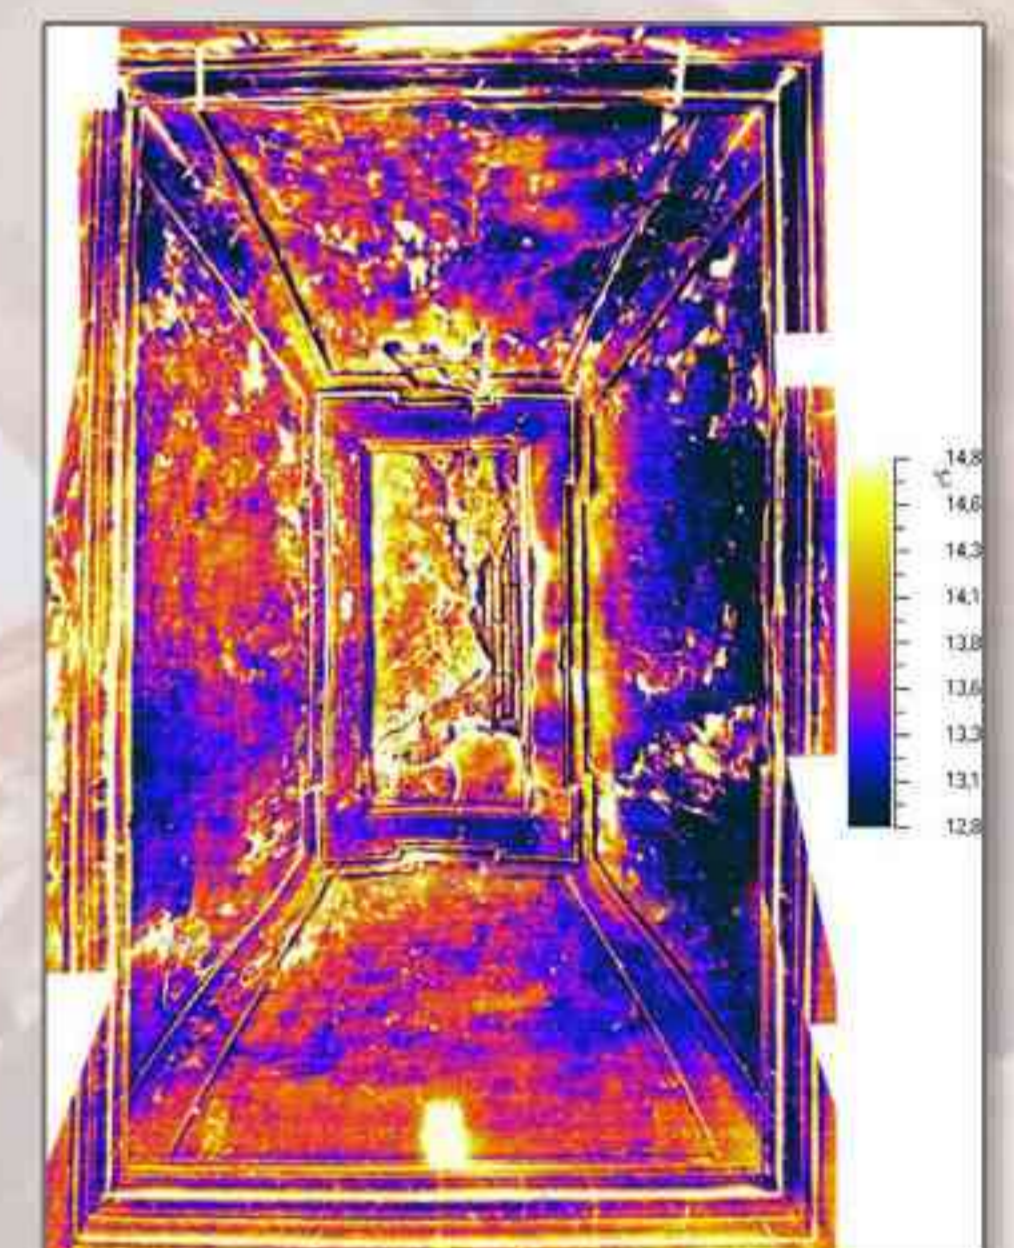
Fig. 10, IR Thermograms composite of vault in room # 6; thermovision allows to find out delamination of plaster and to evaluate percentage of damage.
